What happened?

While carrying out work in an enclosed space, the supply of breathing air became blocked. The staff then immediately went to the exit and took their masks off. The concentration of hazardous substances was such (below the threshold value) that it was possible to take the mask off.

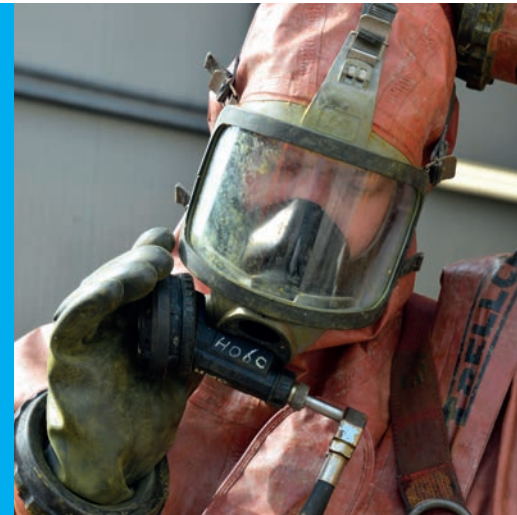
- moisture problems had arisen in the breathing air line system during the work;
- the filter at the breathing air compressor (the 'filling station') that filters moisture and oil out of the air had not been replaced in good time, resulting in moisture accumulating in the breathing air cylinders when they were filled;
- the moisture froze when the reducer valve was working at a high load, which blocked the supply of breathing air;
- the prescribed maximum length for the breathing air hose had been exceeded for 2 employees, resulting in the reducer valve not remaining at a sufficiently high pressure and creating underpressure in the mask, which caused the breathing air supply to stop.

- Always check the certificates and other required documents before starting work: has the equipment got a certificate and has the right maintenance been carried out?
- Always follow the supplier's instructions regarding the maximum number of people connected up to a single reducer valve.
- Always check that the maximum hose length is appropriate for the breathing air line system. This is indicated on the system's rating plate.
- If there is any doubt, ask your supervisor or the QHSE/prevention adviser.
